DEALING WITH COASTAL EROSION IN THE GULF OF MOTTAMA

HELVETAS Myanmar

31 DECEMBER 2018

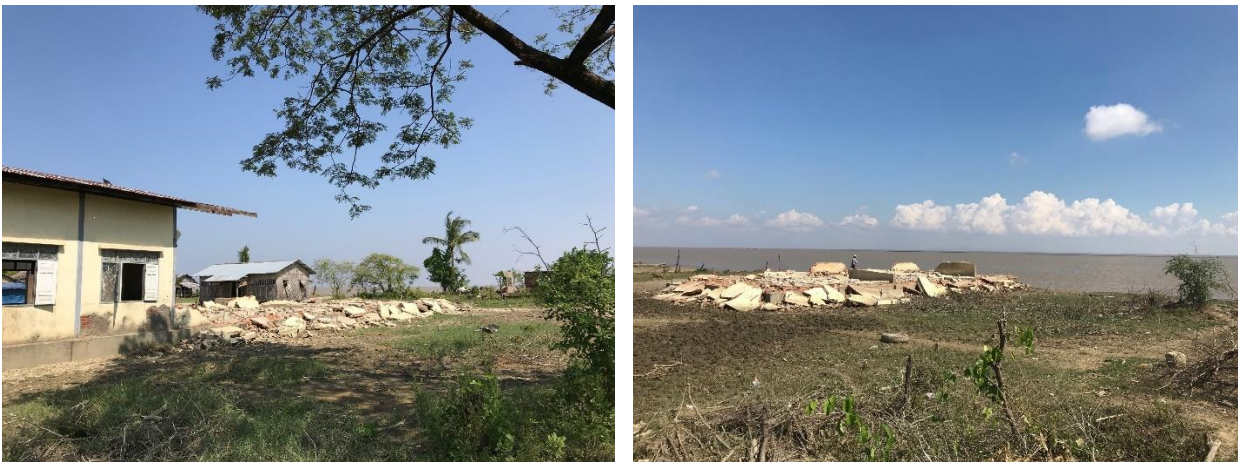
Figure 1.2 Two pictures (Courtesy Helvetas) of the same school. The picture at the left taken on 07.11.2017; the picture on the right was taken only one month later on 12.12.2017.

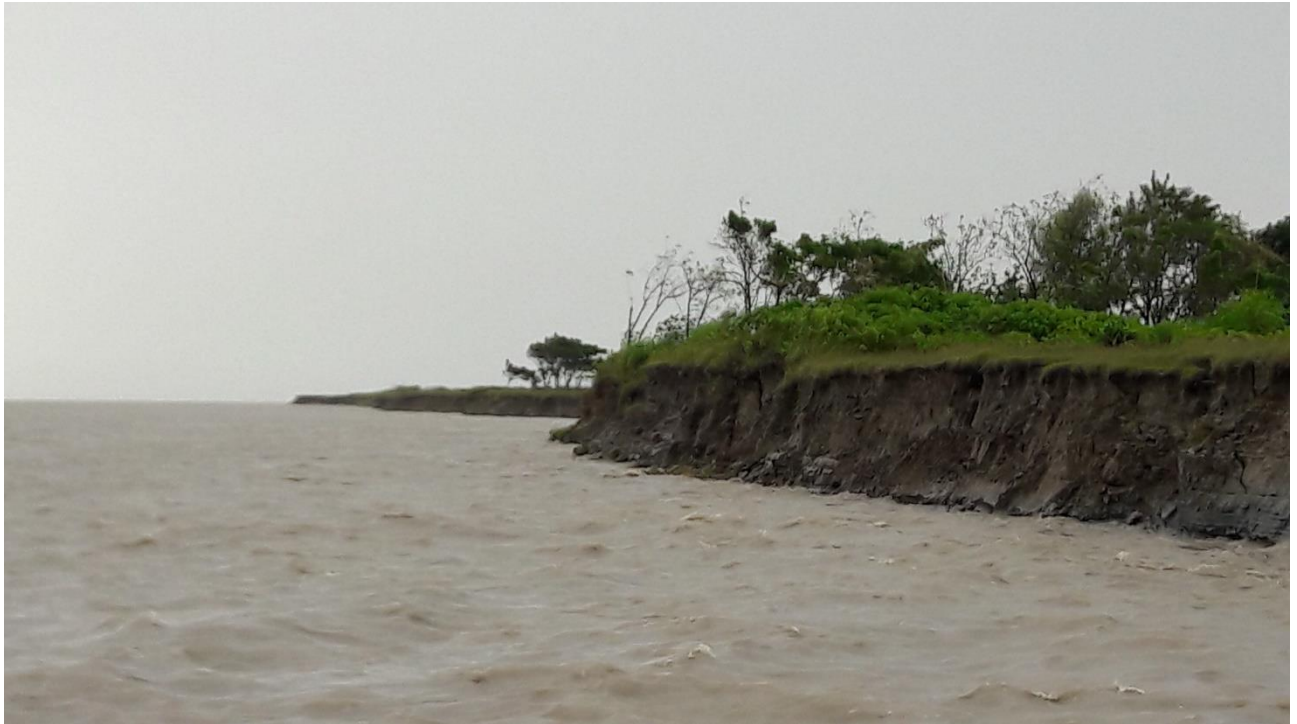
Figure 1.4 View of the western shoreline of the Gulf of Mottama (29 September 2018; near An Lan Pya). The steep, nearly vertical bank and the slumped blocks are evidence of the main erosional mechanism of the bank (slope collapse) that results from the ongoing landward migration of the tidal channel.

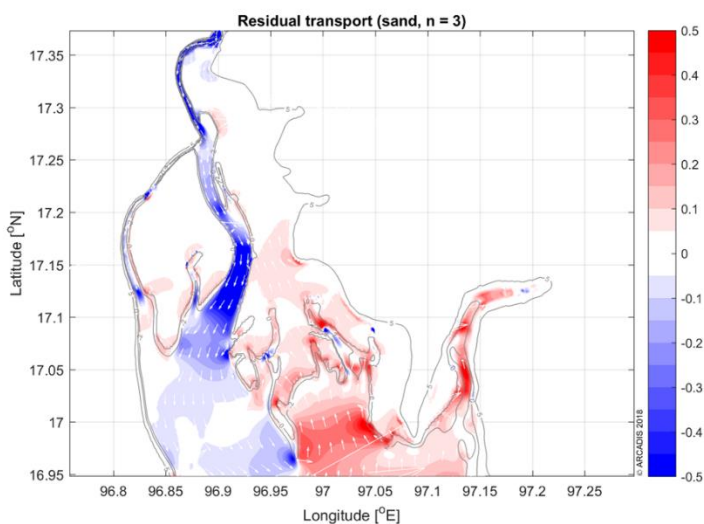
Figure 2.7 Factor indicating the residual transport of sand during mean spring tide in combination with a high river discharge. Blue colors indicate transport downstream (eb) and red colors indicate transport upstream (flood).

The same has been computed for the wet season ($4000 \text{ m}^3/\text{s}$); see Figure 2-7. The main channel system in the center of the estuary, which is connected to the Sittaung river now shows downstream residual bedload transport capacity. In the eastern part of the estuary, the residual transport is still directed in the upstream direction.

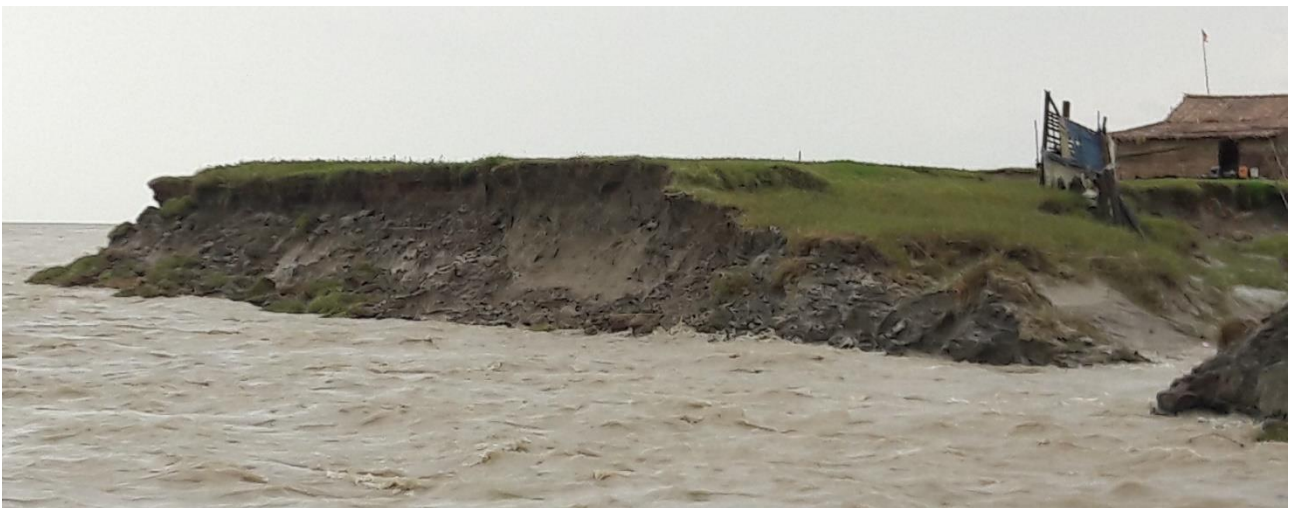
View of the western shoreline of the Gulf of Mottama, near Ah Lan Pya (29 September 2018). The steep, nearly vertical bank and the slumped blocks are evidence of the main erosional mechanism of the bank (slope collapse) that results from the ongoing landward migration of the tidal channel.

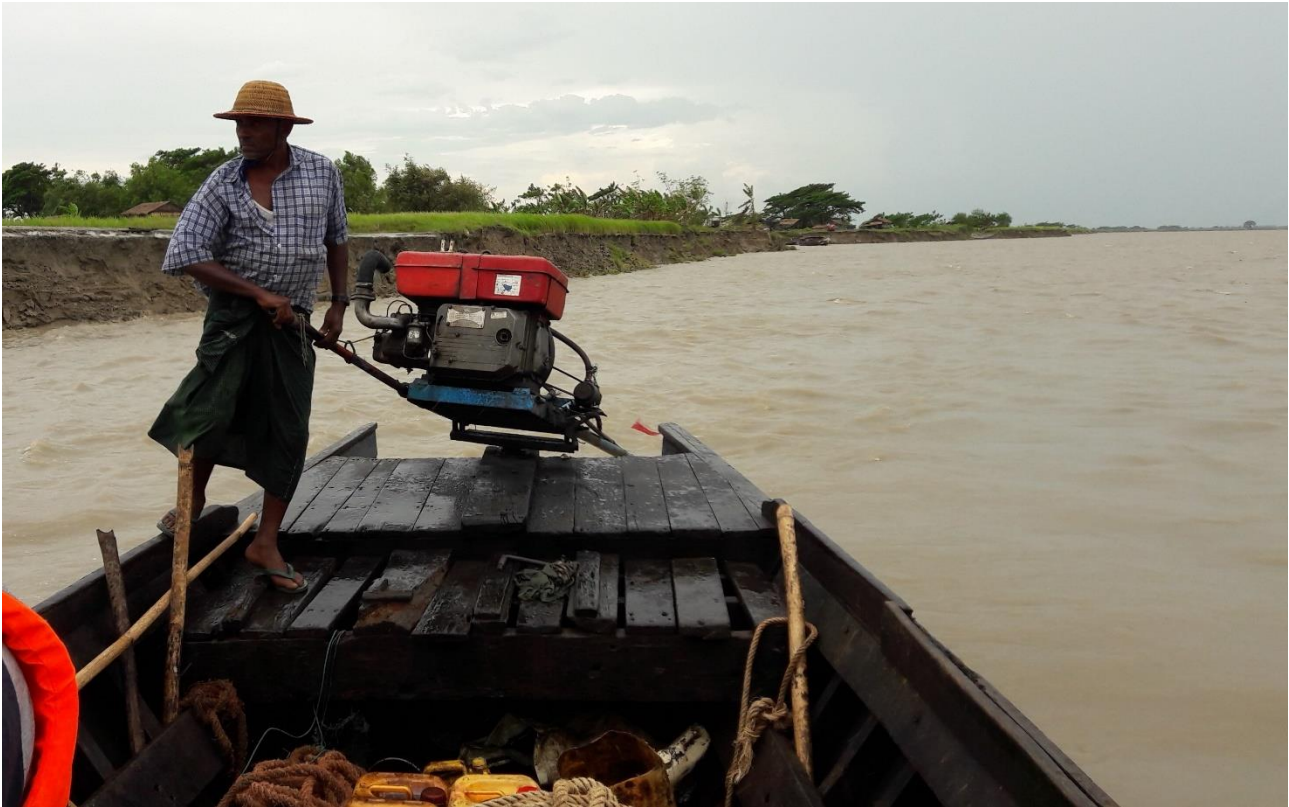
Rice fields being lost to the sea (photo taken on 29 September 2018 north of Ah Lan Pya, near Kywe Te)

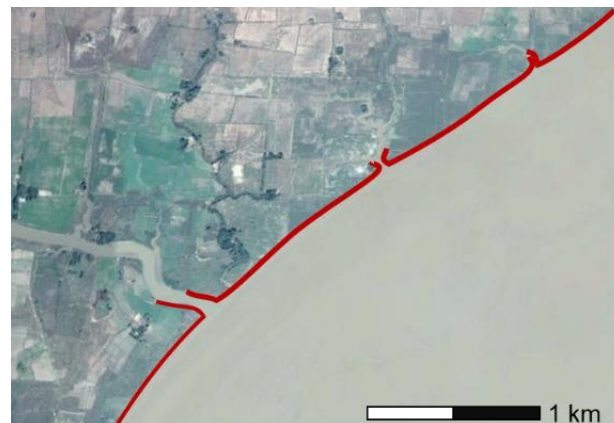
Figure 4.3 Part of the western shoreline of the Sittaung estuary, with extent of alongshore protection against erosion.

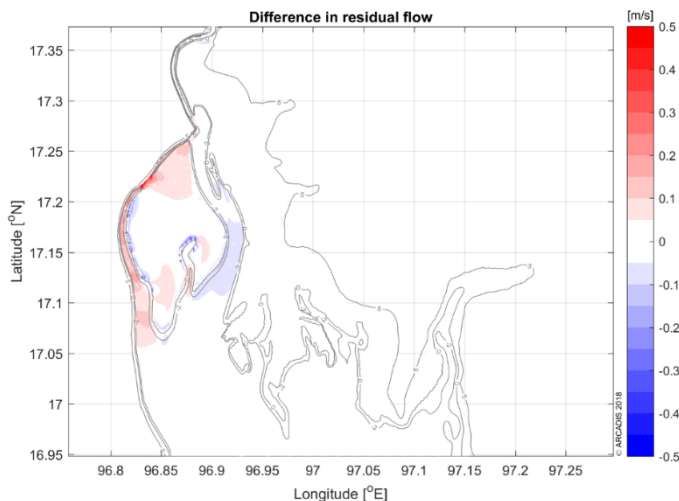
Figure 4.4 Difference in the residual flow as a result of the heightening of the western tidal flat.

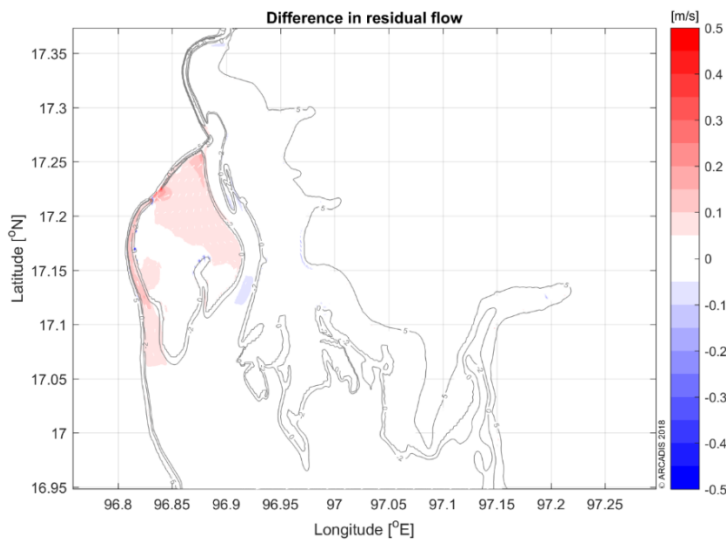
Figure 4.5 Difference in the residual flow as a result of the added vegetation on the western tidal flat
